27 September 2021

617-02/21
TSB file R21H0099

SUBJECT: RAIL SAFETY ADVISORY LETTER 02/21
Roller bearing failure resulting in derailment of Ottawa Light Rail Transit vehicle

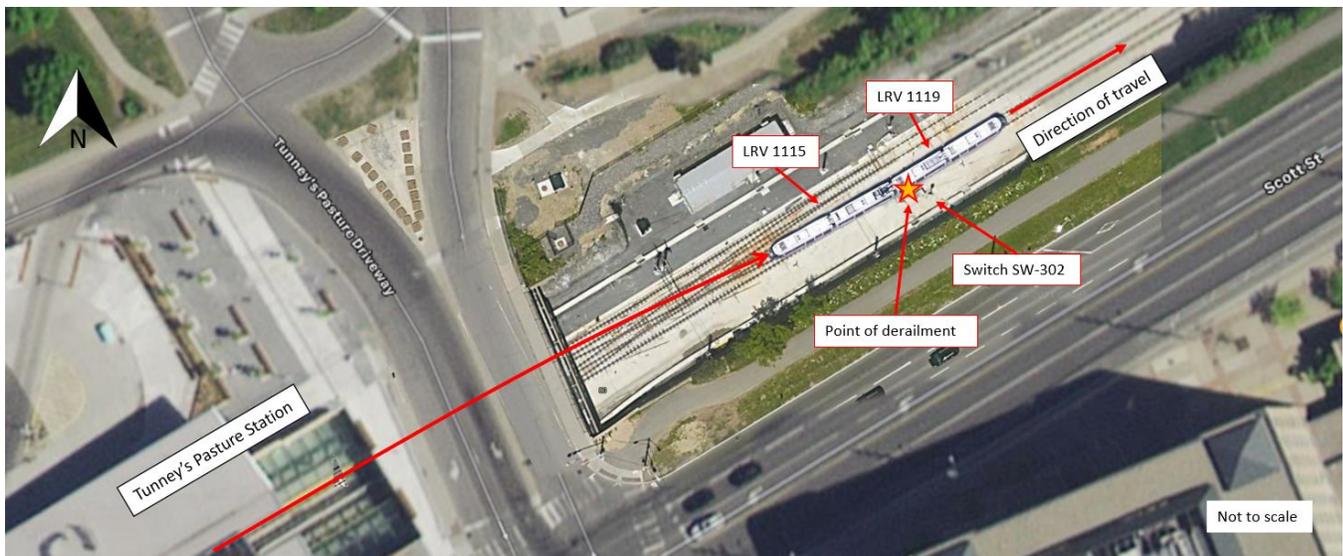
On 08 August 2021 at about 2034,³ an eastbound OLRT commuter train (the train) was proceeding from the north track to the south track over the SW-302 south crossover switch at a speed of about 30 km/h when it derailed about 90 m east of Tunney's Pasture Station in Ottawa, Ontario (Figure 4). There were no passengers on board at the time of the accident.

Site examination identified that while the train was traversing the crossover the No. 3 wheel climbed the rail and derailed to the field side of the south track. The mate No. 4 wheel on the same axle derailed to the gauge side of the north rail and came to rest between the rails. The concrete ties and the tie plates of the south track sustained impact damage.

Figure 4. Derailment location (Source: Google Earth, with TSB annotations)

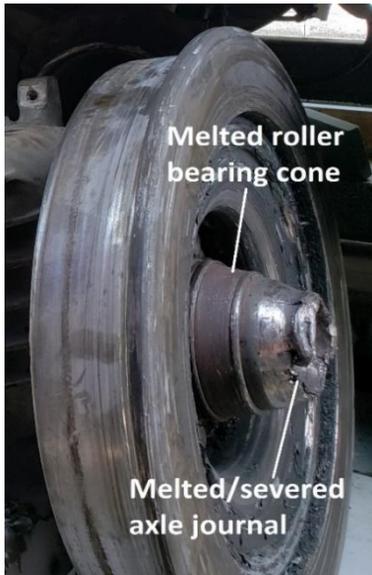
- The No. 3 wheel had severed from the axle due to a previously undetected catastrophic roller bearing failure and subsequent axle journal burn-off (Figures 6 and 7).

Figure 6. Severed wheel and axle assemblies from No. 3 position (Source: TSB)

Alstom's root cause failure analysis suggested that the roller bearing failure was related to the loosening of the large locking nut that holds the cartridge assembly together.

- All failed or loose cartridge assemblies were replaced with new ones before the LRVs were returned to service.
- A new periodic inspection was implemented. The inspection requires the LRV to be elevated in order to inspect the cartridge assemblies from beneath the bogies. With the use of a pry bar, axial endplay clearance measurements are recorded for each cartridge assembly. Loose

As demonstrated by this derailment, there can be serious consequences resulting from an overheated roller bearing failure on an LRV in commuter passenger service. OLRT may wish to ensure that it has heat detection systems in place to monitor temperatures of LRV cartridge roller bearing assemblies in order to detect overheated roller bearings in a timely manner and intervene before an in-service catastrophic roller bearing failure occurs.

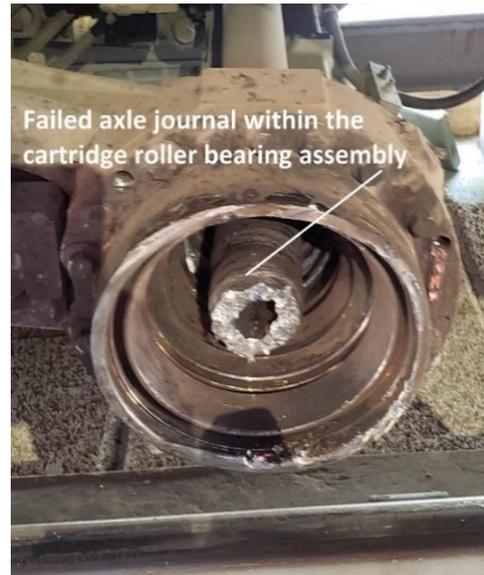
Figure 7. Damaged cartridge roller bearing assembly, No. 3 position on axle B (Source: TSB)

- Roller bearing rollers were later found on the track near uOttawa Station. This suggests that, as the train travelled westward between 1325 and 1450, a cartridge assembly failed and some rollers were expelled.
