617-03/21
TSB file R21H0121

SUBJECT: RAIL SAFETY ADVISORY LETTER 03/21
Work procedures for Ottawa Light Rail Transit vehicle maintenance

Ottawa Light Rail Transit main-track train derailment on 08 August 2021

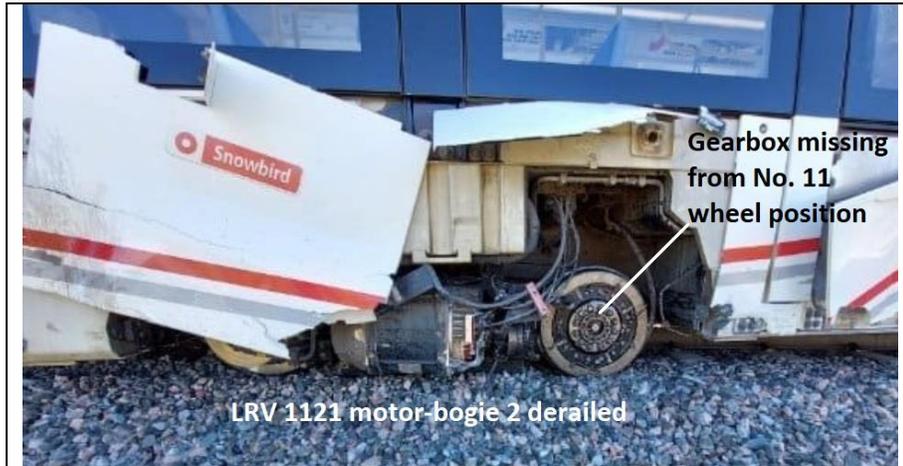
BM2 on LRV 1121 had derailed to the north side of the track. The motor gearbox from the No. 11 wheel position had detached from the wheel and was missing (Figure 5).

Figure 5. BM2 on LRV 1121 derailed and gearbox missing from wheel position No. 11 (Source: Alstom)

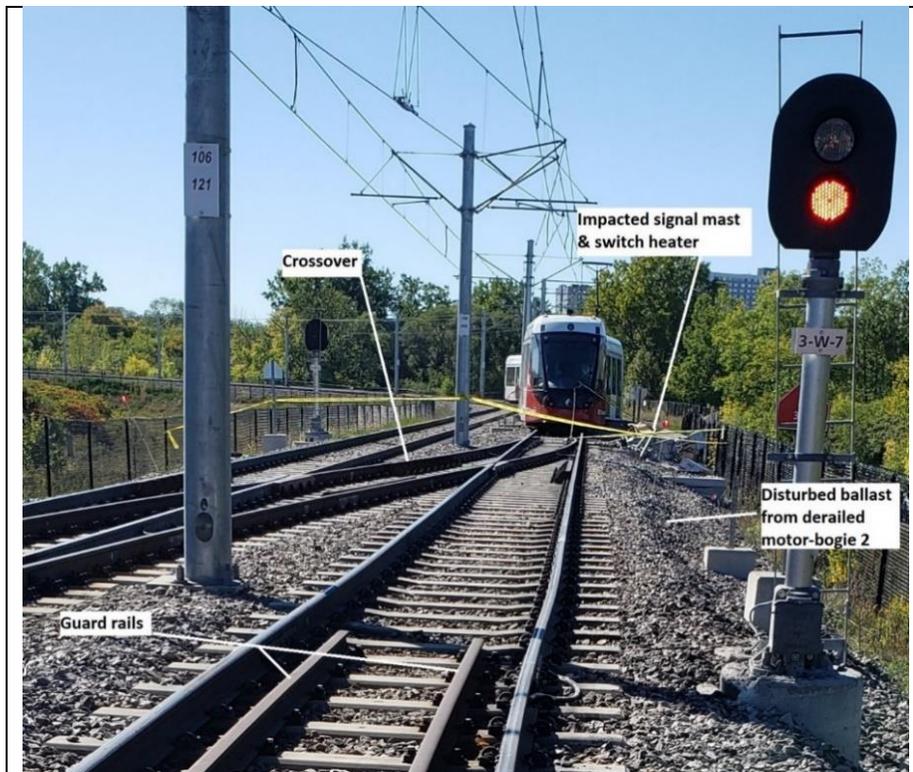
During the derailment, LRV 1121 had contacted and destroyed a signal mast and switch heater that were adjacent to, and north of, track 1 (Figure 6).

Figure 6. Looking west at LRV 1121 on track 1 (Source: TSB)

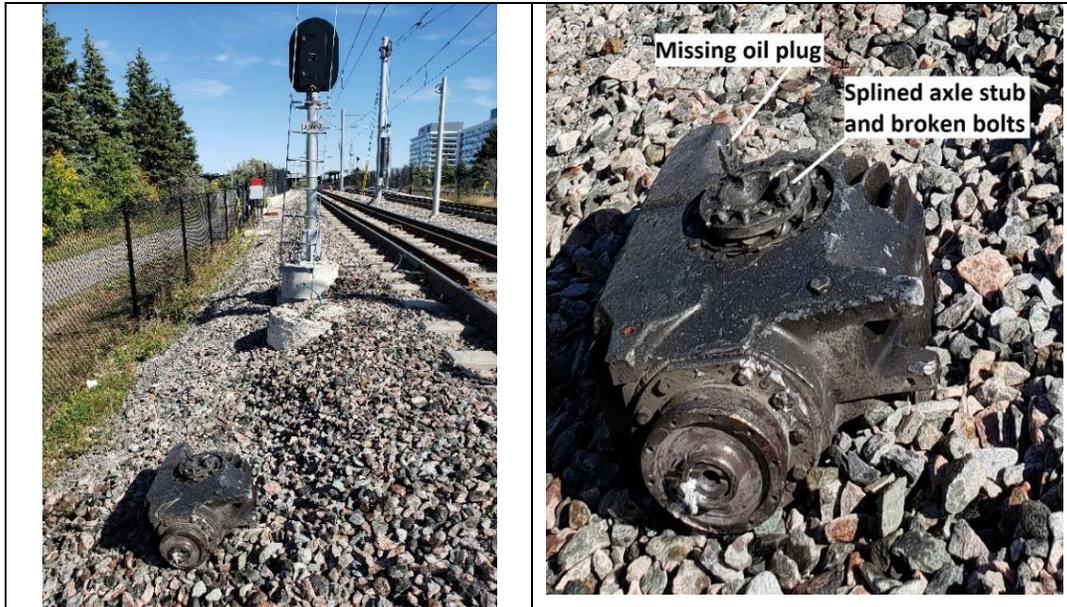
From LRV 1121 eastward, the ballast along the north side of track 1 was disturbed for about 1400 feet. The gearbox from the BM2 No. 11 wheel position was located on the ballast just north of the track. An oil plug was missing from the gearbox (Figures 7 and 8).

Figure 7. Looking east at gearbox (Source: TSB) **Figure 8.** Gearbox close-up (Source: TSB)

There were no impact marks observed on the gearbox surface in the area of the missing oil plug. Only 1 litre of the 6.1 litres of oil required to fill the gearbox oil was recovered. Although Alstom procedures required that the oil fill plug be torqued and the head of the plug be marked, no such indications were observed. Although gearboxes are to be inspected for oil leaks prior to release from MSF 1, TSB observations suggest that Alstom procedures were not followed and there was likely no oil plug installed at the time of the LRV 1121 inspection at MSF 1.

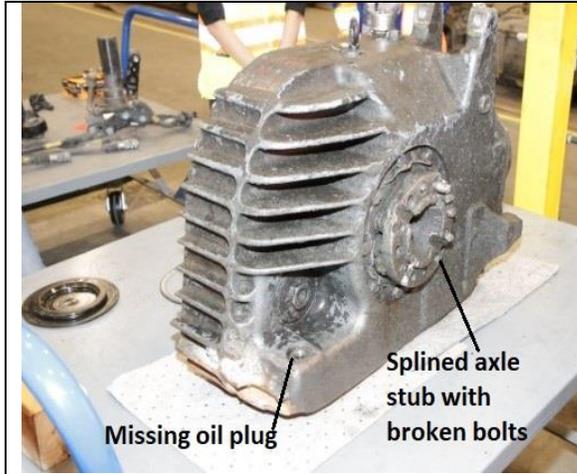
The splined axle stub is normally secured to the wheel hub with 12 fine-thread, class 12.9 M16x1.5 bolts. In this case, all 12 of the bolts from the BM2 No. 11 wheel position had failed (Figures 9 and 10).

Figure 9. Gearbox as received (Source: TSB)

- Several bolts were significantly deformed. This deformation was only possible if the mating surfaces of the splined axle stub and wheel hub had separated.
- A total of 3 threaded portions of the bolts were recovered from within the wheel hub mounting holes. The failed end of 1 bolt was examined using a low-power optical microscope and a scanning electron microscope. The fracture had initiated at the root of a thread and exhibited beachmarks that progressed uniformly from the outside in, in a radial manner, characteristics that are typical of high-stress, low-cycle fatigue.

Changes in stress loading are required in order for fatigue to develop. If the bolts that secured the assembly had been fully torqued, such loading changes would not have occurred.

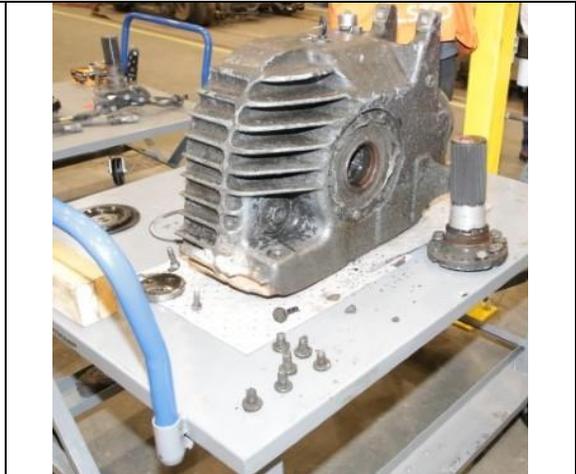
Figure 10. Splined axle stub removed (Source: TSB)

The 12 bolts that secured the splined axle stub to the BM2 No. 11 wheel hub of LRV 1121 were not adequately torqued when installed during refurbishment. LRV 1121 was then allowed to enter service without a complete set of torque data or Alstom verification that all work was complete. The lack of applied torque led to the failure of all 12 retaining bolts after only about 800 km of service. Failure of the bolts resulted in a disconnection of the drivetrain from wheel position No. 11. Components from the disconnected drivetrain subsequently dropped from the LRV and contacted the track infrastructure, which ultimately caused the derailment near the middle of the north passenger platform at Tremblay Station.
