617-03/21
TSB file R21H0121

SUBJECT: RAIL SAFETY ADVISORY LETTER 03/21
Work procedures for Ottawa Light Rail Transit vehicle maintenance

Ottawa Light Rail Transit main-track train derailment on 08 August 2021

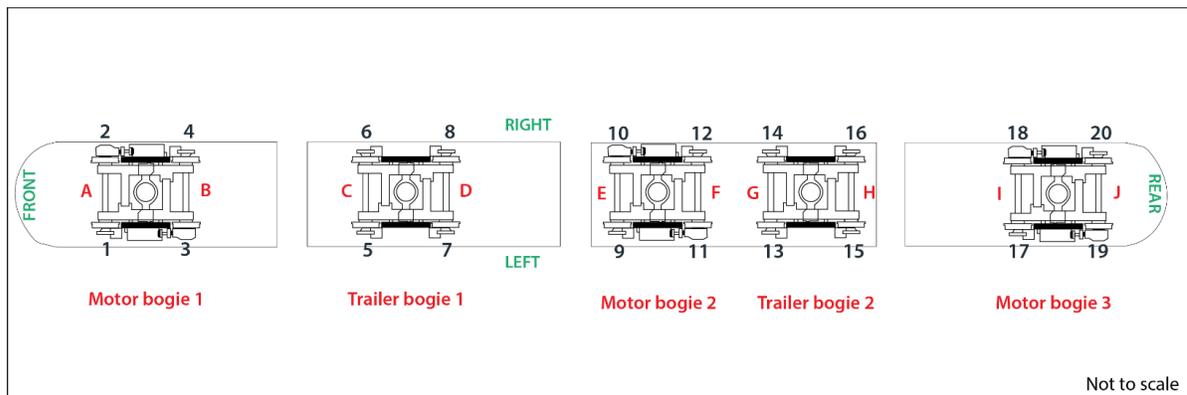
Figure 1. Schematic of an LRV showing bogies. Official Alstom nomenclature identifies the axle locations as A–J but Alstom refers to axle positions 1–10 and wheel positions 1–20 (Source: TSB)

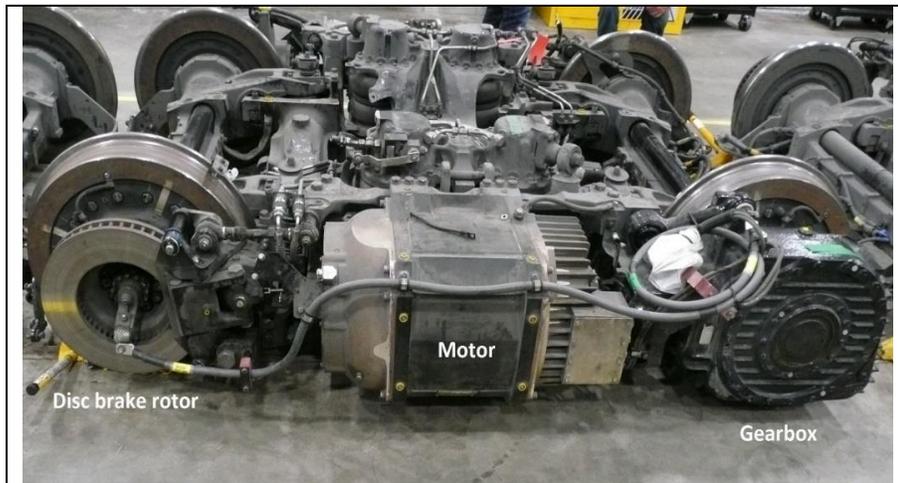
Figure 2. Alstom LRV Iponam motor bogie (Source: TSB)

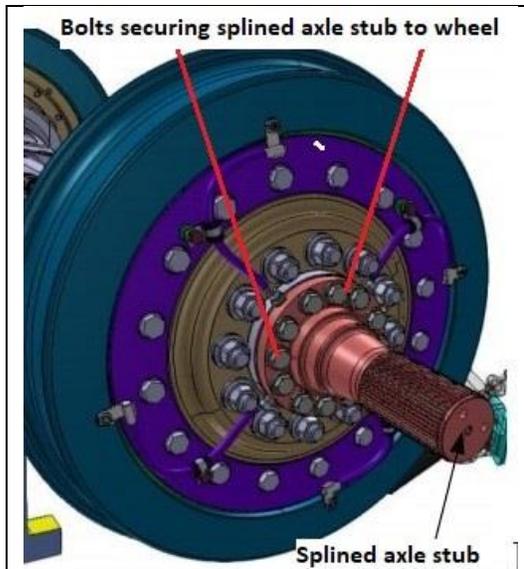
Each motor bogie is equipped with 2 motors—1 on each side of the bogie. Power from each motor is transmitted to a drive wheel through a gearbox that interconnects with a splined axle stub, also referred to as a reducer hub, which is secured to the wheel hub with 12 bolts (Figure 3). Disc brake rotors are attached to the wheel hub opposite the drive wheel of each motor bogie wheel set (Figure 4), and to each wheel of the trailer bogies. The rotors are also secured to the wheel hub with 12 bolts.

Figure 3. Splined axle stub secured to a wheel hub (Source: Alstom, with TSB annotations)

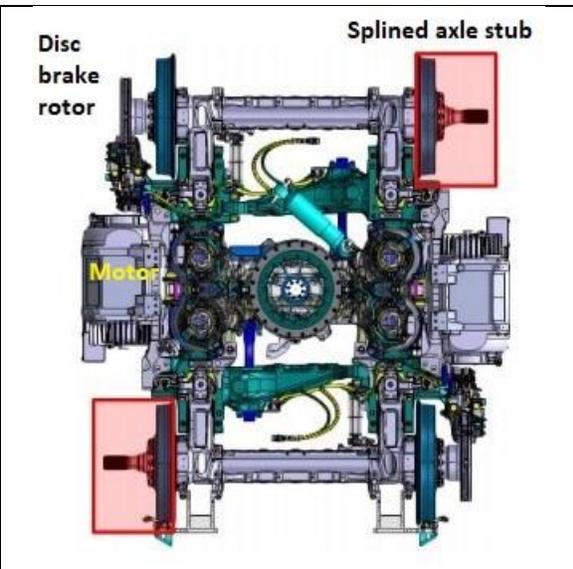
Figure 4. Bogie schematic (Source: Alstom, with TSB annotations)
